Mast Tang Reinforcement Project

Project Performed by Michael Clements and Colin Gilbert, Fleet One
on the Mast of Too Wicked, 304
November 26, 2023

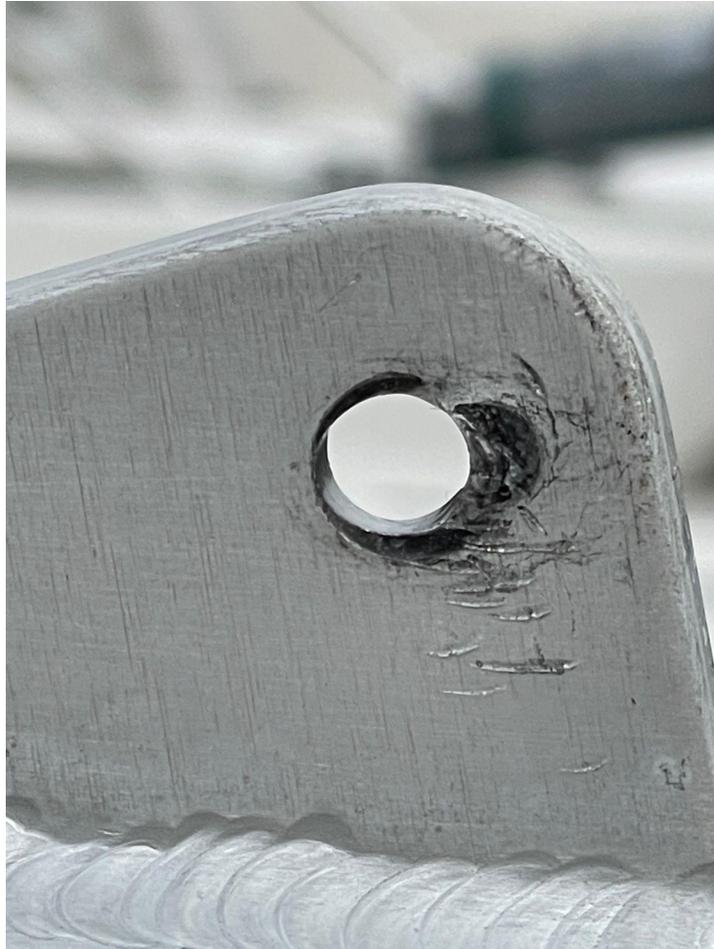
Most 242 masts encounter the same problem: a relatively thin cross pin that connects the upper forestay swivel to the mast tang, which in turn wears its way over time through the aluminum and elongates the hole.

As you can see from the photos below of Too Wicked's 1 year old mast, it is already suffering from slight hole elongation, coupled with excess wear on the flat surfaces below the hole, presumably from the pin tilting slightly when under load.
