Mast Tang Reinforcement Project

Project Performed by Michael Clements and Colin Gilbert, Fleet One
on the Mast of Too Wicked, 304
November 26, 2023

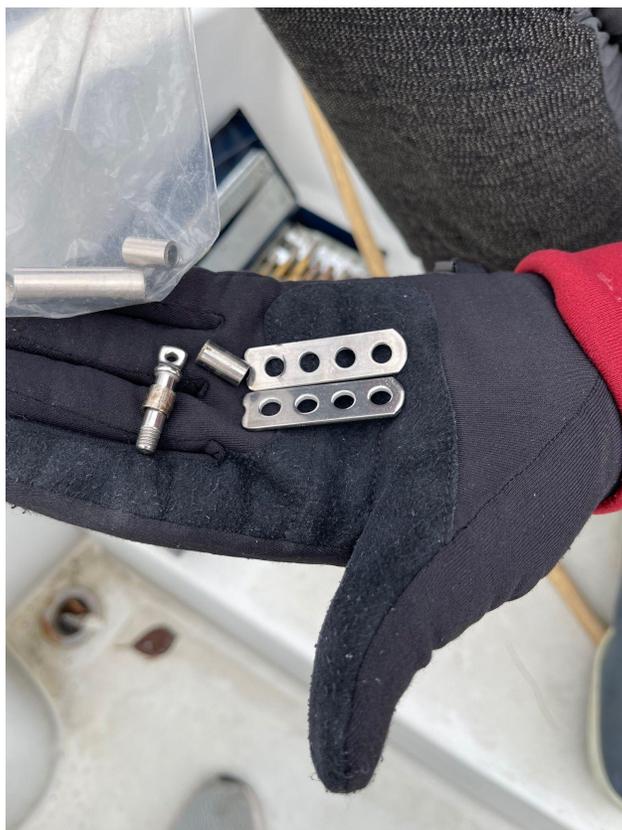
The Barton tangs can be procured at Steveston Marine for about \$4 and cut in half as shown. You also need a few stainless bushings. Jim Hyslop was kind enough to donate his to our project, with some left over (which we will use on Matt Collingwood's mast in the Spring), so he can advise where best to obtain these. Perhaps one of the Metal Supermarkets stocks them.

Not shown is a 1" to 1.5" bolt, 2 small washers, and a lock-nut for the upper bolt assembly.
